## SB, Steering linkage not according to specs, CRT 36 and CRT 48 Trowels, 2026-03

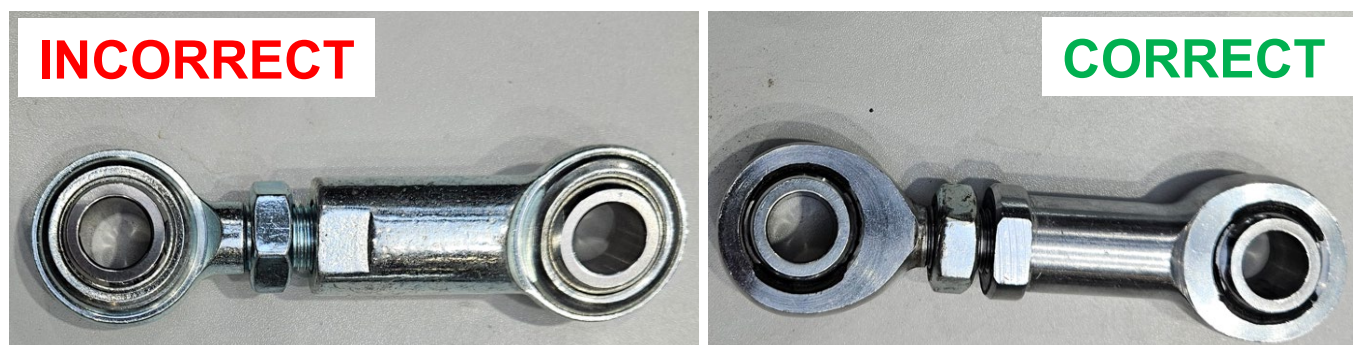
Some CRT 36 and CRT 48 trowels have been produced with steering linkages 599038401 that are not according to specs. This might cause them to snap.

Identify the correct part according to the pictures below.

Replace all the linkages 599038401 to secure normal operation of the machine.

Scrap all the incorrect parts in the local stock.
