## SB, Gearbox locking pin, FS5000, FS7000, 3-speed gearbox, 2025-03

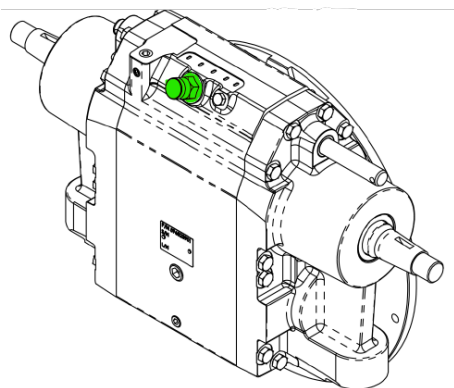
FS7000D/DL

The locking pin with counter nut on the 3-speed gearbox must not be overtightened, there is a risk that over time and together with vibrations, the screw will break. The correct procedure when securing the selected gear is to tighten the locking pin finger-tight and then tighten the counter nut with a tool and the lowest possible torque. This must not supersede 50Nm.
